AFFTC-TR-61-54
October 1961

**CATEGORY II YJ
AND J85-GE-5
ENGINE FOLLOW-ON
EVALUATIONS**

**AIR FORCE FLIGHT TEST CENTER
EDWARDS AIR FORCE BASE, CALIFORNIA
AIR FORCE SYSTEMS COMMAND
UNITED STATES AIR FORCE**

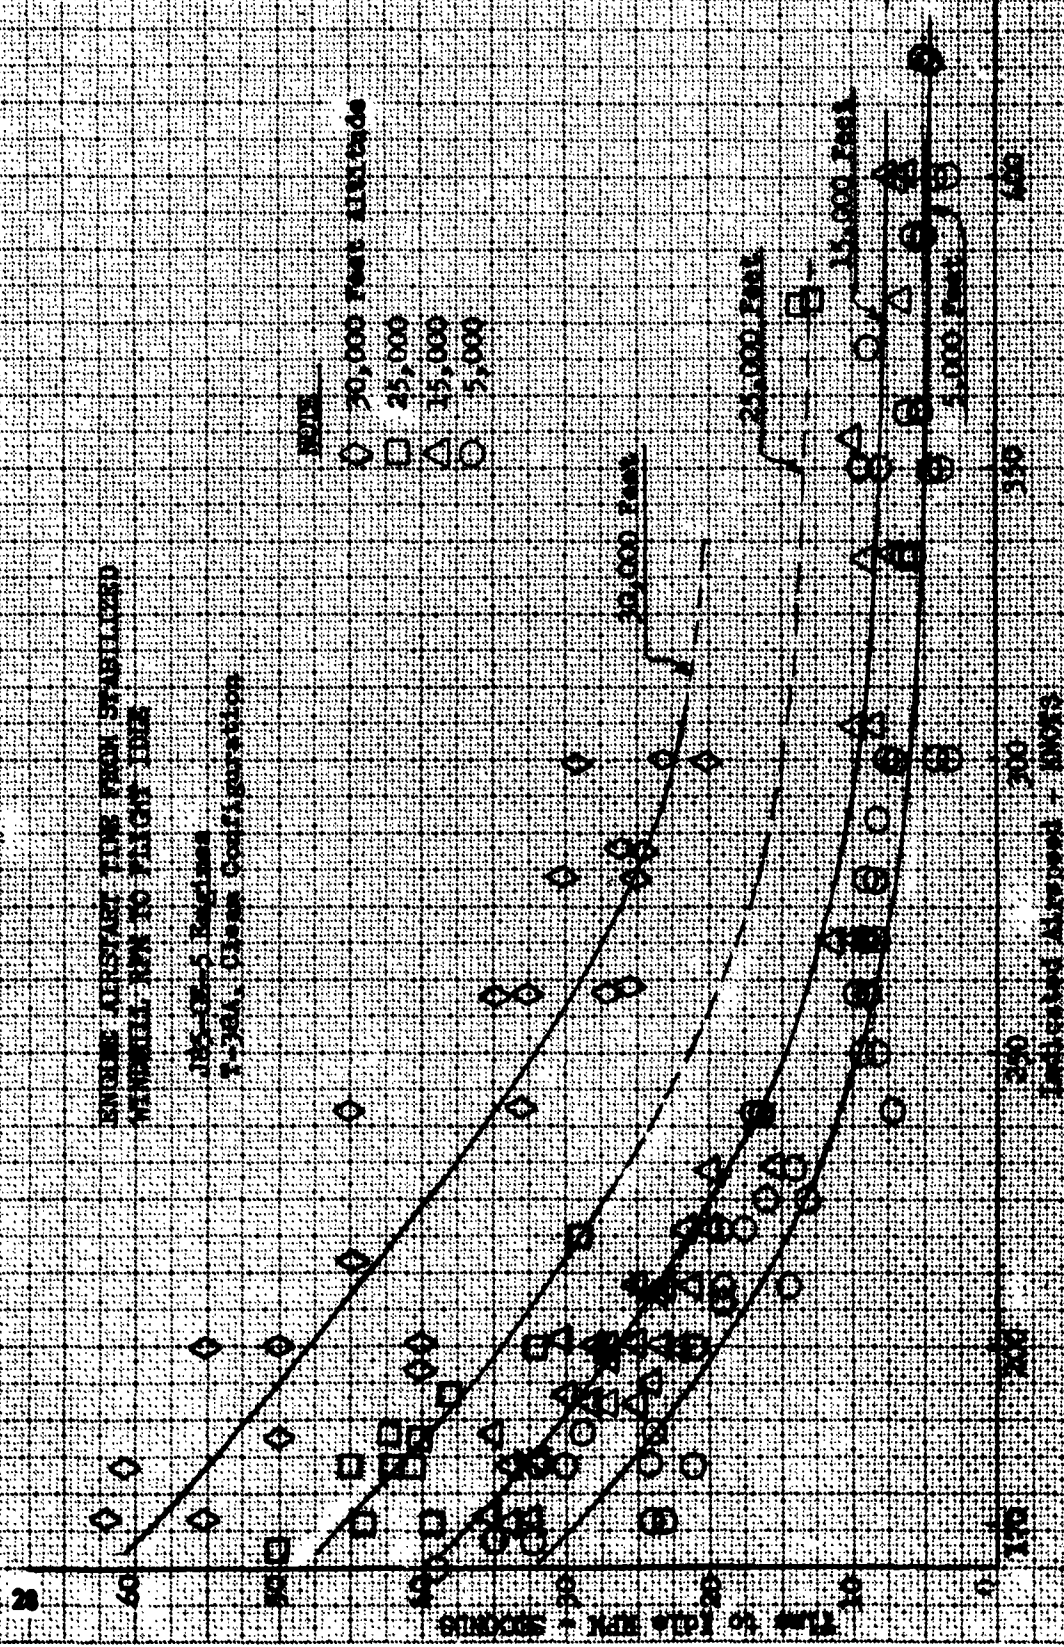
FIGURE 7

The response of the engine to rapid increases of the throttle at altitude was not satisfactory. During burst accelerations to military or maximum power at or slightly below the rollback line on Fig. 7, the engine RPM would oscillate for 3 or 4 seconds about a point (94 to 97 percent) less than the normal RPM level and then slowly reach a stabilized normal condition. Above this line on the same figure, severe rollback of engine speed would occur without the afterburner becoming lit. If the throttle was not quickly retarded to idle as the engine RPM decreased through 80 to 70 percent RPM, the engine would consistently flameout. Engine overspeeds on bursts reached a maximum of 102.5 percent. (3)
